# GARAPA RAIN SCREEN WEATHERING EVALUATION

## Penetrating Oil

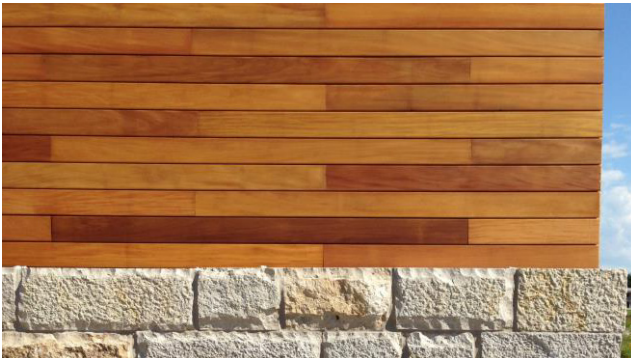
Day 1

To assess the weathering performance of the finish and determine maintenance needs, a mock-up was built. The images below depict a Garapa rain screen that was pre-treated with a single layer of clear penetrating oil.
